Manhole Inspection Summary

Manhole # S33I__034MH

Insp Date: **3/26/08 1:01 PM**

Location Address: **200 w. lombard**

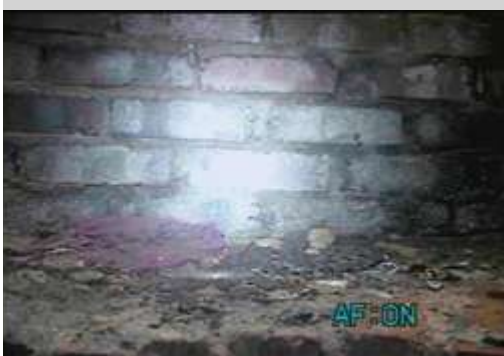
Misc

bench debris

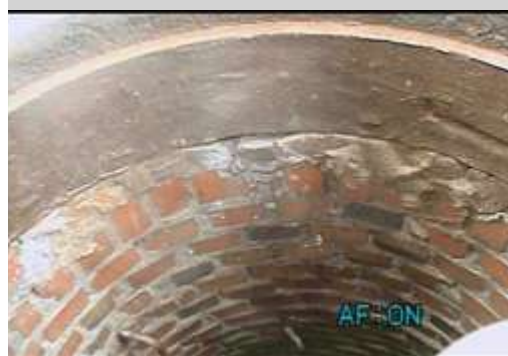
Misc

☒ Exists Material: **Brick and Concrete** ☐ Parged Height: **4** (in.)

frame adjustment

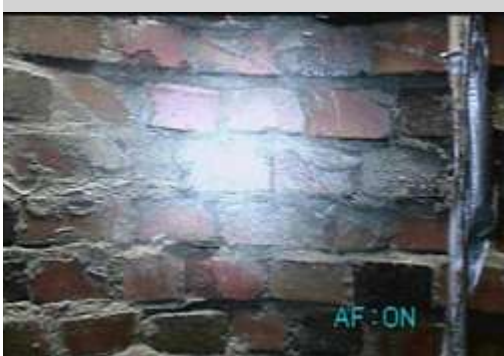
Defect 5

Condition: ☐ Sound ☒ **Cracked** ☐ Root Intrusion ☐ Loose Brick ☐ Deteriorated

cracked corbel

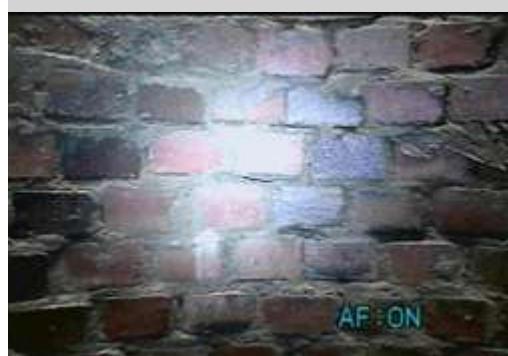
Defect 4

Condition: ☐ Sound ☒ **Cracked** ☐ Root Intrusion ☐ Loose Brick ☐ Deteriorated

cracked barrel

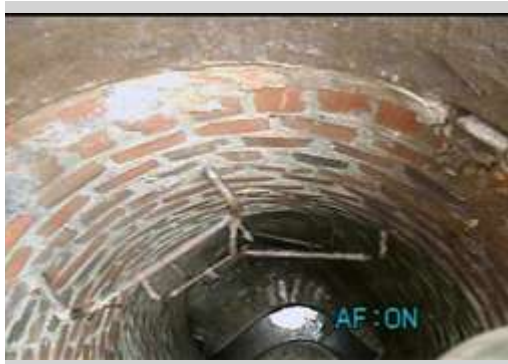
Defect 2

Count: **10** Missing: **0** ☒ **Corroded**

Corroded steps

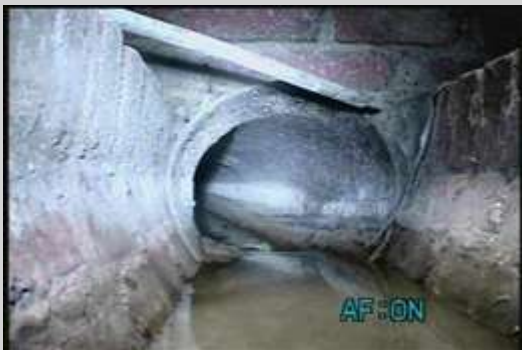
12 O'Clock Outflow

10 in. Circular Gravity Sewer
Pipe Out @ 12 O'Clock

Pipe Material: **Clay** ☐ Pipe Lined

Invert Depth: **15.16** (ft.) Flow Characteristics: **Slow**

Infiltration: **None** Pipe Seal Cond: **Unknown**

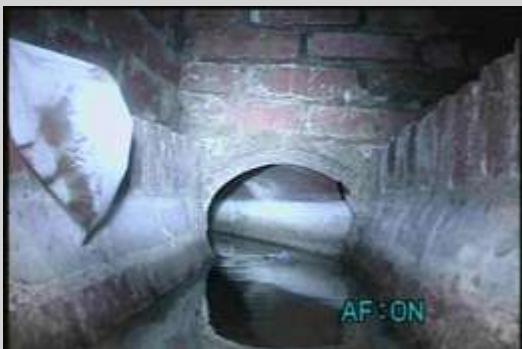
9 O'Clock Inflow

10 in. Circular Gravity Sewer
Pipe In @ 9 O'Clock

Pipe Material: **Clay** ☐ Pipe Lined

Invert Depth: **15.13** (ft.) Flow Characteristics: **Slow**

Infiltration: **None** Pipe Seal Cond: **Unknown**
